Building Inspection Report

5416 E. Mountain Sky Ave Phoenix, AZ 85044

Inspection Date:
03/13/2013

Prepared By:
Artisan Home Inspection
1411 E. Oranewood Ave
Phoenix, AZ. 85020

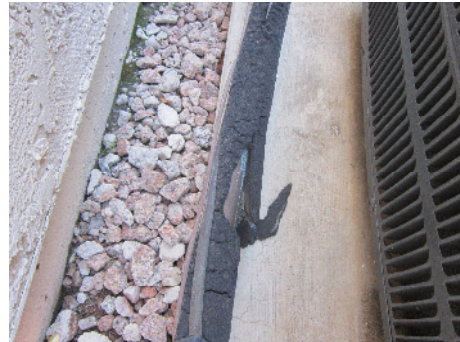
exterior AC coolant line insulation damage

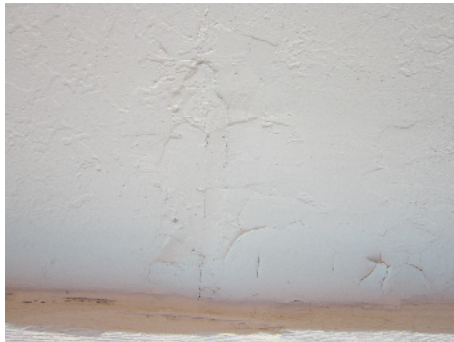
Minor patching to ceiling on patio, roof OK

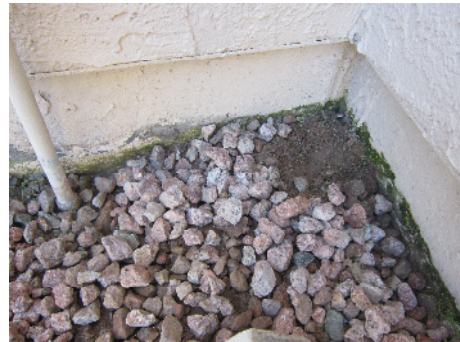
minor plumbing leak at rear foundation, possible pool filler

A minor leak at the rear of the home exterior was observed. Possibly the PVC plumbing supply for the pool auto fill. Have a plumber or pool company further evaluate. Replacement of aging faucet supply lines and valve stops is recommended.

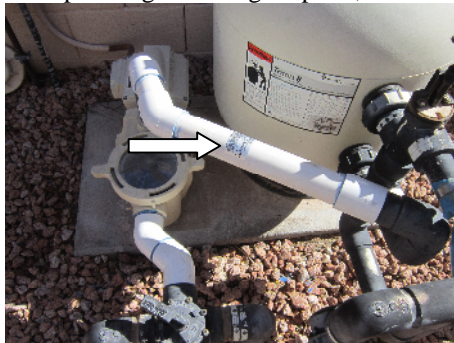
Pool plumbing PVC needs paint to prevent UV damage

Paint is recommended to be applied to the PVC plumbing to protect from UV damage.

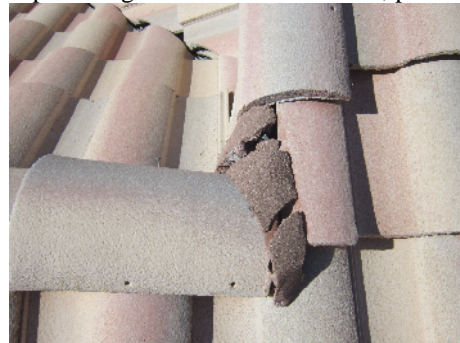
mortar caps broken need repair

Minor cracked tiles were observed. Mortar caps are beginning to crack and minor head lap issue at the ridge was observed. Have a qualified roofer further evaluate and make repairs. Common issues and not serious. Seal cracks and nail heads with sealant and repair or replace cracked tiles.

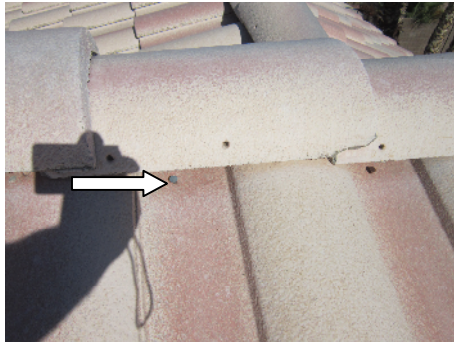
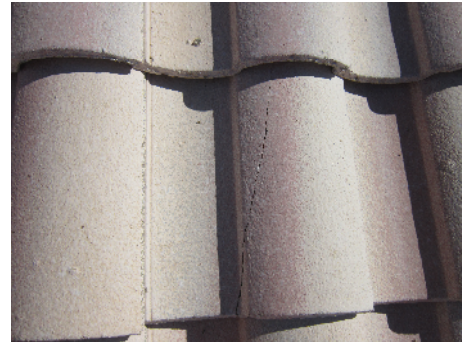
Typical head lap issue at ridge, exposed nails need sealant and minor tile cracks

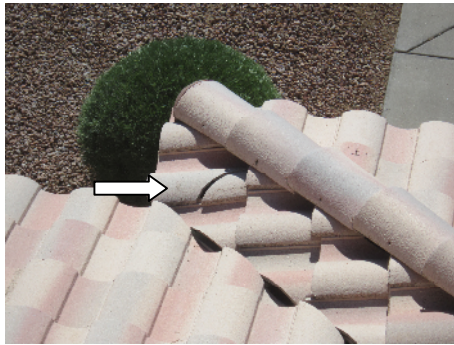
Minor tile cracks in some areas

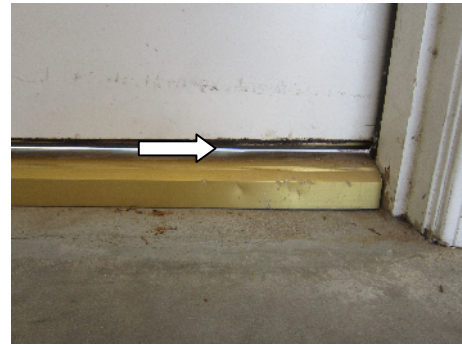
garage rear entry door needs threshold repaired to prevent rodents

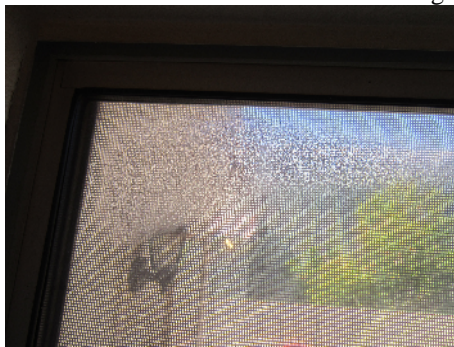
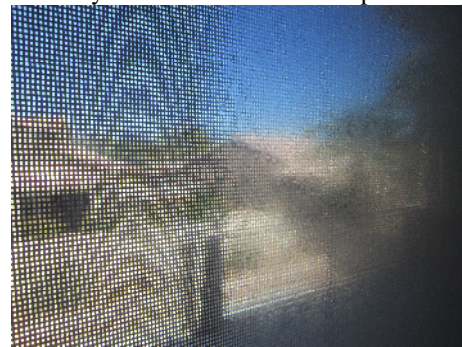
Lower hall bath window and upper master bedroom sliding glass door have lost seal

- **Repair:** The glass of the sliding glass door in the dining room has lost its seal. This has resulted in condensation developing between the panes of glass. This “fogging” of the glass is primarily a cosmetic concern, but may need to be replaced because it has lost its insulating value. Please visit www.getthefogout.com for other options.

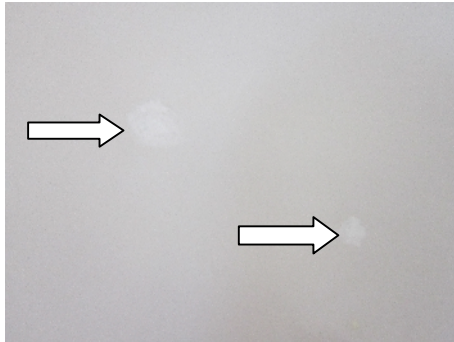
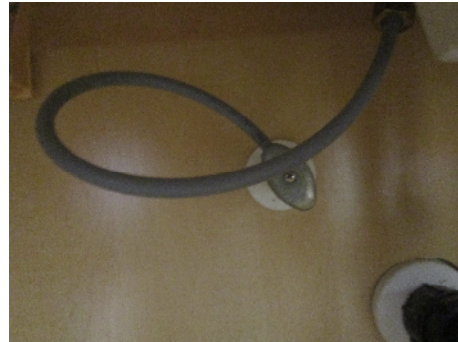
Upper Jack and Jill bath tub damage below water line older plastic supply lines and valves should be replaced

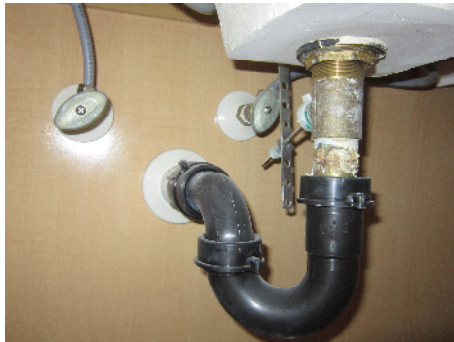
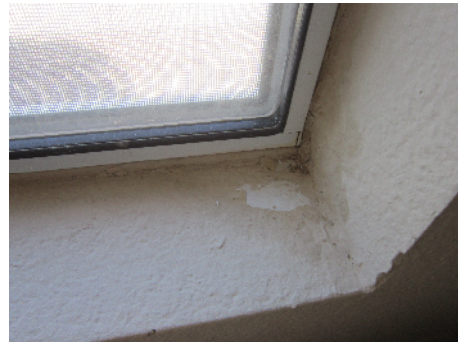
Faucet supply lines and stops old, tail pieces corroding minor water intrusion around windows

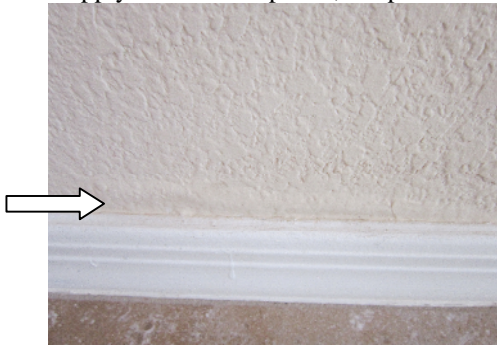
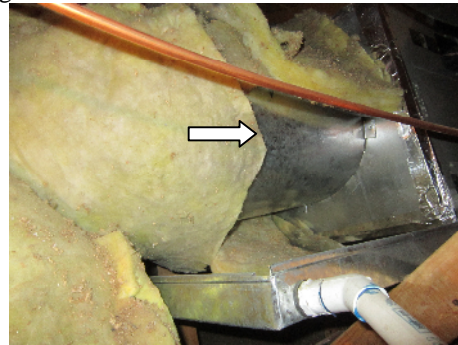
Minor water damage at windows and on the exterior wall in the dining area was observed. Common for windows of this age and quality. Not serious.

Minor water damage to drywall in dining area AC ducting not insulated on Trane air handler

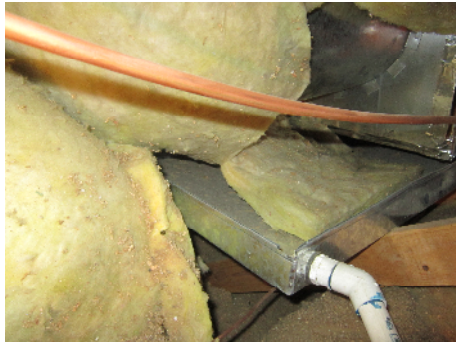
Duct insulation is laying in condensate pan

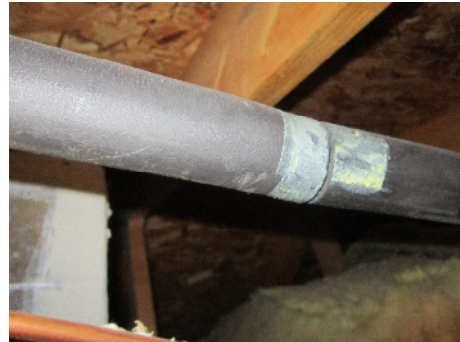
seams of suction line insulation need taping

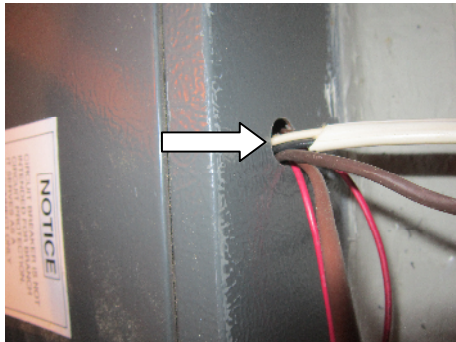
Wiring entering the air handler case should be protected with a collar

The Goodman air handler needs a collar around the wiring entering the case to protect it from chaffing. The insulation on the coolant lines is damaged on the exterior and needs the seams taped in the attic. The duct insulation is loose on the Trane air handler and should be secured around the duct. Trusses were cut when the Goodman air handler was installed and the responsible AC company should be consulted on the damage.

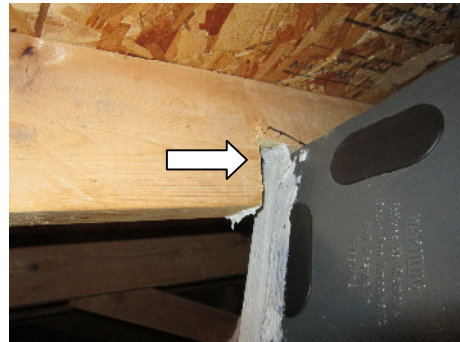
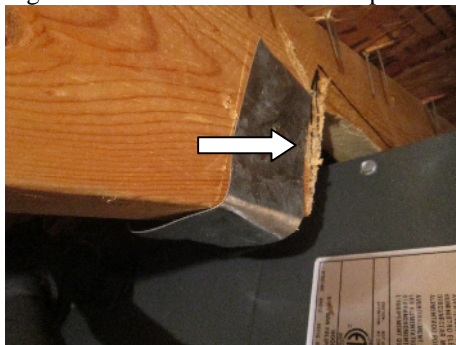
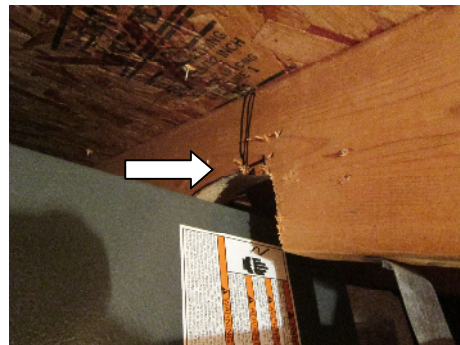
- **Improve:** Truss members shall not be cut, notched, drilled, spliced or otherwise altered in any way without the approval of a registered design professional. This area should be evaluated by the manufactures roof truss engineer and prescribe repairs to be done by a qualified contractor as per the IRC R802.10.4. 3 trusses notched more than 50%, strut removed, have evaluated by a Structural Engineer.

3 consecutive truss members were notched beyond 50% and a strut was removed during air handler installation

Have the cut and altered trusses further evaluated by a qualified Structural Engineer and consult the AC company on the work.

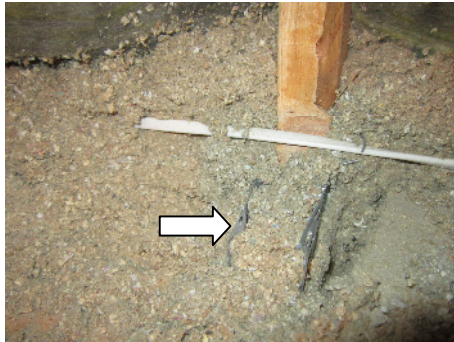
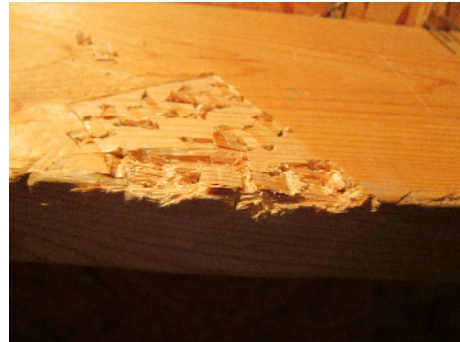
Truss nailing web observed in insulation and nailing web removed from upper truss member
