Building Inspection Report

1342 E. Brill St. Phoenix, AZ 85006

Inspection Date:
05/27/2013

Prepared By:
Artisan Home Inspection
1411 E. Orangewood Ave
Phoenix, AZ. 85020

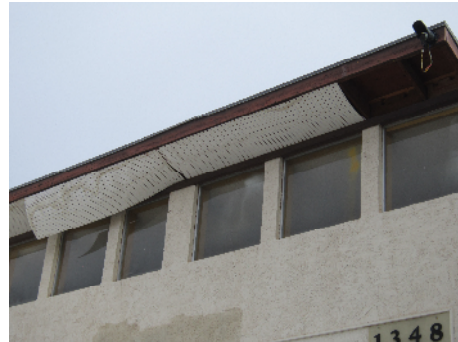
water damage to adjacent of subject home

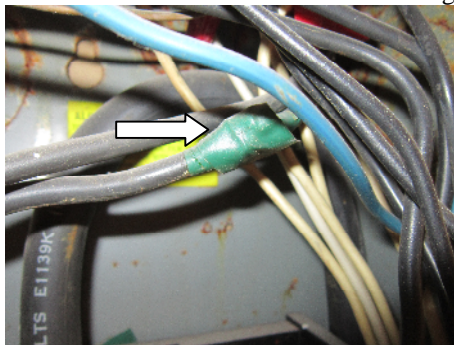
- **Repair:** Poor electrical connections within the main distribution panel should be improved. **220 connection without wire nut.**
- **Monitor:** The main distribution panel shows evidence of rusting, **suggesting the presence of moisture.** This area should be monitored. If rusting continues, or if moisture is evident in the vicinity of the panel, an electrician should be consulted.

220 wire splice should not be taped, wire nut

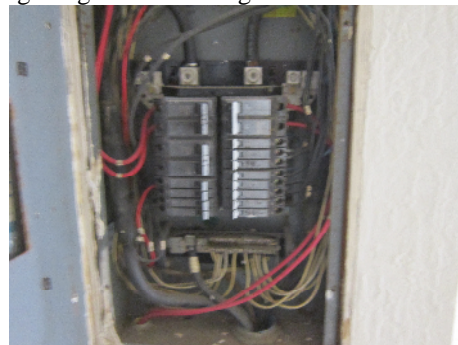
Main electrical panel is inside the home. With Arizona being an arid climate, and the main panel inside the home, the panel should NOT be rusted. Evidence of water intrusion in the home.

- **Monitor:** The service box shows evidence of rusting, **suggesting the presence of moisture.** This area should be monitored. If rusting continues, or if moisture is evident in the vicinity of the service box, an electrician should be consulted. Rusted electrical components are unsafe.

interior panel is rusty, water intrusion?

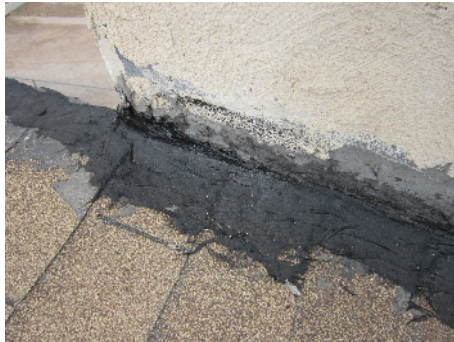
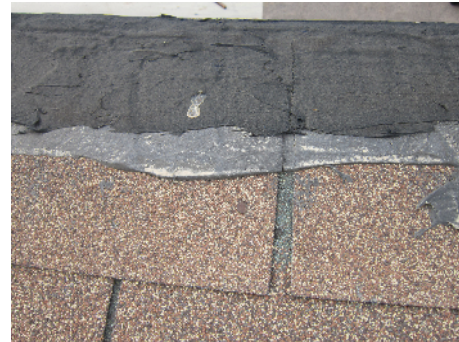
- **Repair:** The installation of the flashing is incomplete and should be repaired to avoid leaks. **No metal flashing along parapet walls was observed. Patching with roof cement only.**
- **Repair:** Nail heads are exposed at the shingles. They should be sealed to reduce risk of leaks. **Improper nailing of shingles exposed nails. Remove and re shingle properly.**

Roofing repairs recently done show cement patching only, no metal installed

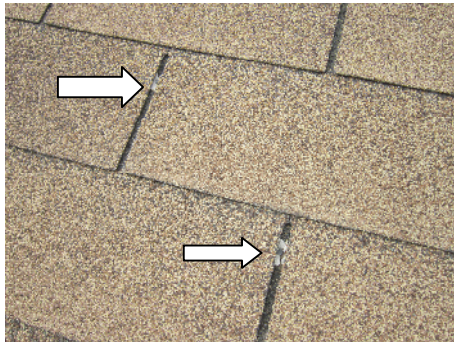
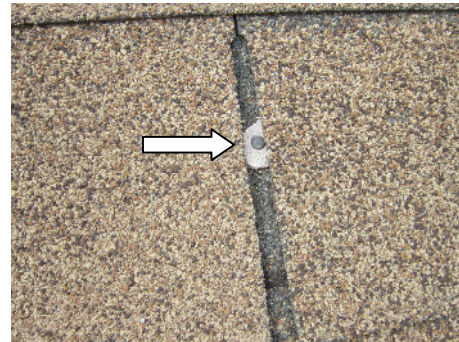
Roof shingles improperly nailed exposing many nails to water

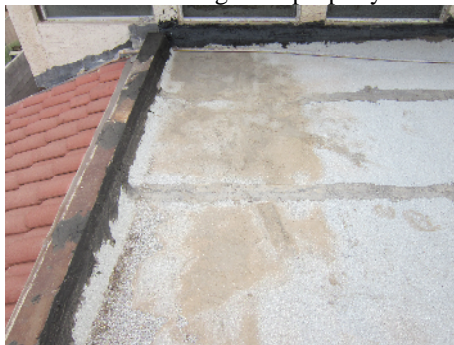
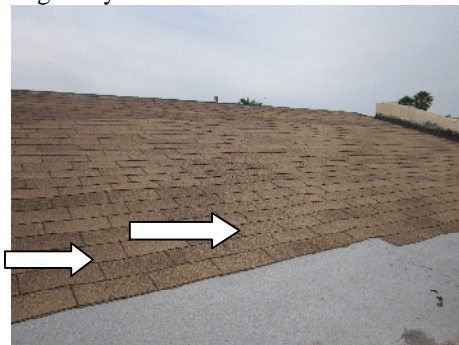
- **Monitor:** Some roof sheathing sags. This is common where prefabricated roof trusses are spaced two feet apart, allowing sagging between trusses. Additional support may be needed when re-roofing. **Possible water damage to sheathing under improperly installed shingles. Have roof checked by qualified roofer.**

- **Monitor:** The roofing is near the end of its useful life. Water appears to pond on the membrane. This leads to a shortened life and increased potential for damage if leaks occur. When re-roofing, the roof should be appropriately sloped or drains should be added. Expect to replace this roof soon.
- **Repair:** Open roof membrane seams leak and need to be repaired.
- Replace the roof flashing materials when re-roofing to avoid leaks in these areas.

Ponding evidence on rolled roofing and seams patched sheathing sagging between rafters may be rotted

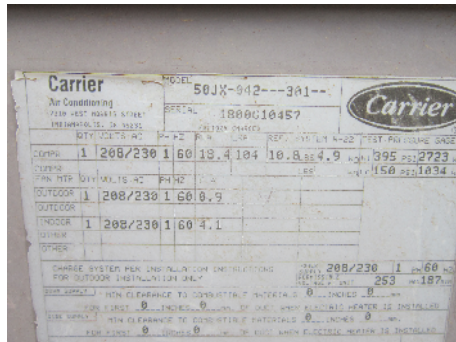
The heat pump is over fused. A 50 amp breaker and non fused plug type disconnect is in use. The system max fuse rating is 35 amps. If supplemental heating strips are not installed, replace 50 amp breaker with 35 amp, or install a 35 amp fuse disconnect to protect compressor from overload if desired.

Carrier Roof Mounted Heat Pump 2000

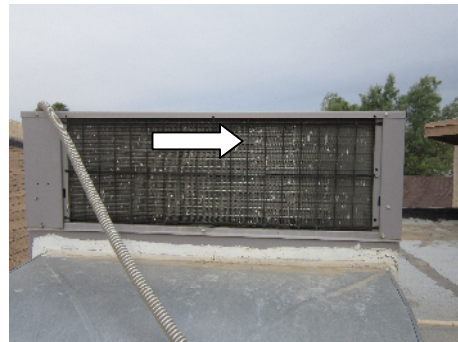
- **Monitor:** As is not uncommon for homes of this age and location, the heat pump is old. It may require a slightly higher level of maintenance, and may be more prone to major component breakdown. Predicting the frequency or time frame for repairs on any mechanical device is virtually impossible.
- **Monitor:** The fins of the outdoor portion of the heat pump were observed to be damaged. This condition can reduce the efficiency of the system. **Hail damage.**

minor hail damage to cooling fins on unit

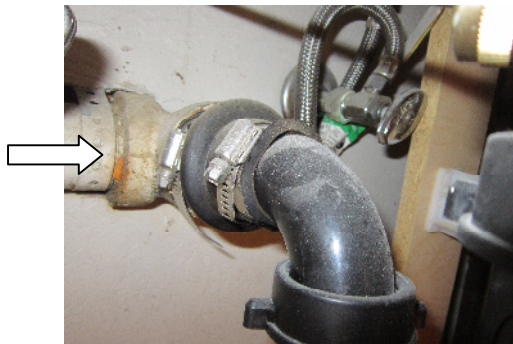
- **Repair:** The waste piping does not have sufficient slope for proper drainage.
- **Monitor:** The waste piping connection is suspect. **Upper floor bath tub drain is connected with a T fitting and not a Y fitting. Drain appears to be leaking at drain pipe connections in laundry area.**

Drain pitch improper and connection suspect

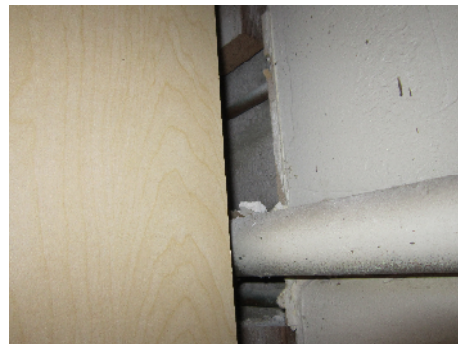
openings inside cabinets need sealing for insects

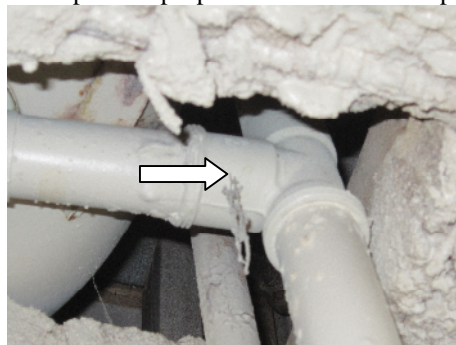
Upper bathtub drain should connect with a Y fitting not T

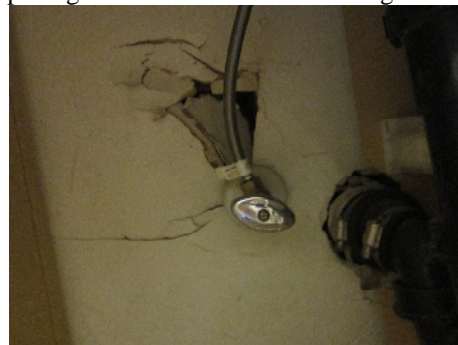
wall openings should be sealed for insects

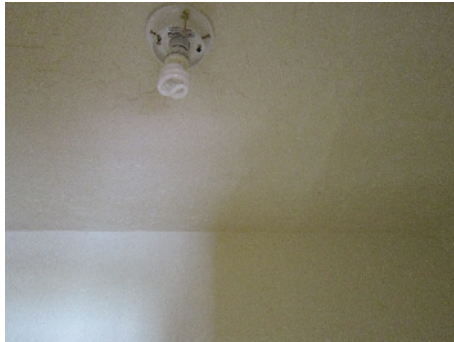
Water damage was observed in the second floor bath. Sagging drywall on the ceiling was observed in the upper bedroom closet. Evidence of roof leaks. Possible mold due to non removal of wet drywall and possible continuing roof leaks. See Roofing Section.

Drywall ceiling sagging from water damage in closet

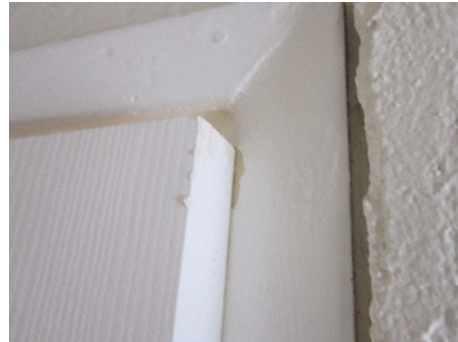
interior doors do not properly close

- **Repair:** Doors throughout should be trimmed or adjusted as necessary to work properly.
- **Improve:** The sliding glass door could be improved to operate freely.
- **Monitor:** The screen for the sliding glass door is missing.

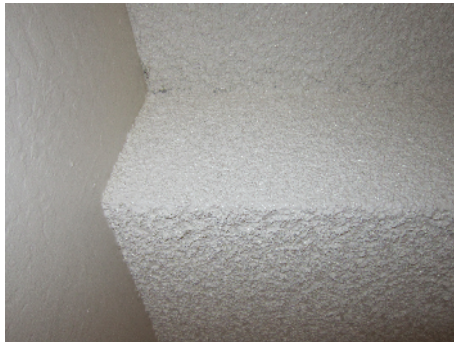
- **Monitor:** Based on the age of this home, there is a possibility the ceiling texture may contain some asbestos. This can only be verified by laboratory analysis which is beyond the scope of this inspection. *The Environmental Protection Agency (E.P.A.) reports that asbestos represents a health hazard if “friable” (damaged, crumbling, or in any state that allows the release of fibers).* If any sections of the ceiling are indeed friable, or become friable over time, a specialist should be engaged. Further guidance is available from the Environmental Protection Agency (E.P.A.). Due to the age of construction, there may be other materials within the home that contain asbestos but are not identified by this inspection report.

Possible asbestos in ceiling texture

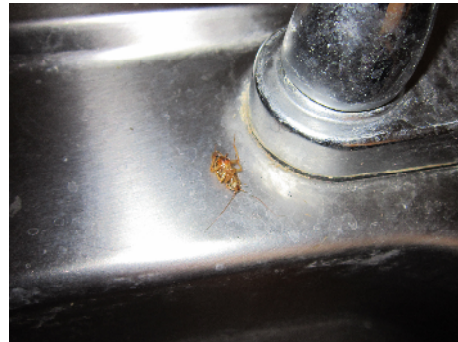
roaches in many areas

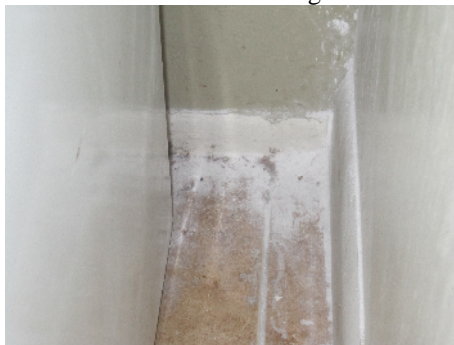
Live roaches were observed inside the dishwasher. Roach powder was observed on the floor behind the stove and refrigerator. Recommend insect exterminator.

Roach powder and dead roaches as well as live roaches were observed

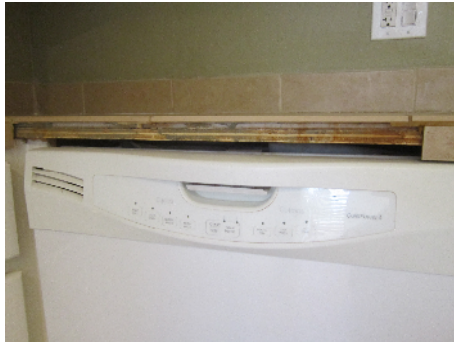
- **Repair:** The kitchen countertop is damaged.

Damaged tile countertop in kitchen

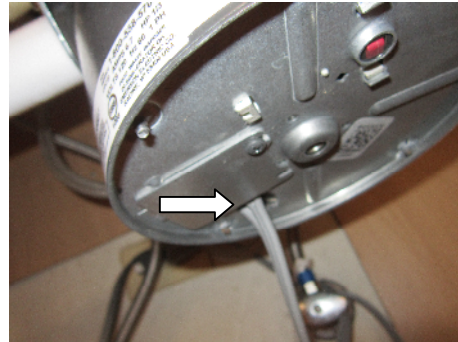
- **Repair:** The wiring leading to the waste disposer appears to be defective. This should be improved as soon as possible.
- **Monitor:** The waste disposer is excessively noisy. **No wire clamp installed. Debris in disposal.**

missing wire clamp on disposal

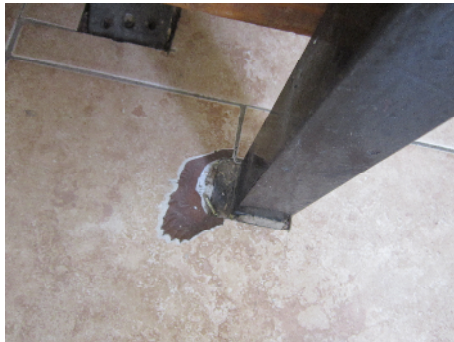
- **Monitor:** The tile floor is cracked. **At stair railing termination.**
- **Monitor:** Seams in the vinyl flooring are not in ideal condition. Improvement is discretionary.

Loose stair railing and broken floor tile at stairway

- **Repair:** Loose stairway handrails should be better secured.
- **Repair:** The size and/or orientation of the stairway “treads” may make the stairway difficult to negotiate. , this condition should be altered for improved safety.

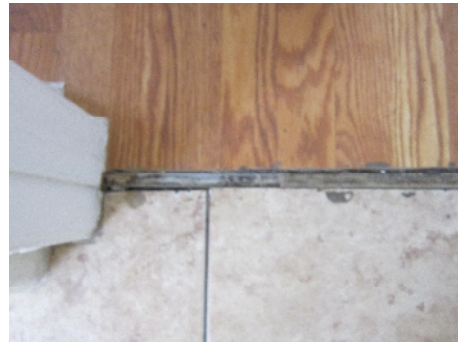
missing floor trim between tile and laminate
