Building Inspection Report

1342 E. Brill St. Phoenix, AZ 85006

Inspection Date:
05/27/2013

Prepared By:
Artisan Home Inspection
1411 E. Orangewood Ave
Phoenix, AZ. 85020

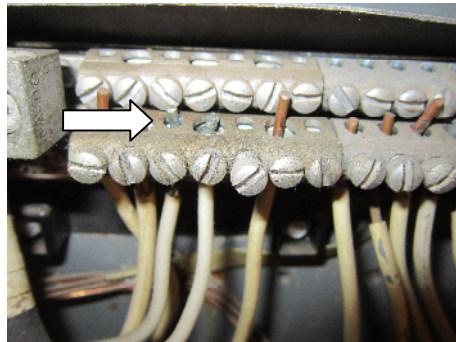
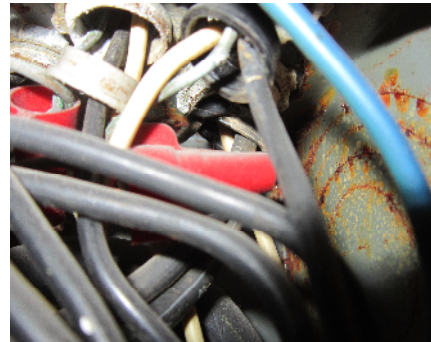
Main electrical panel is inside the home. With Arizona being an arid climate, and the main panel inside the home, the panel should NOT be rusted. Evidence of water intrusion in the home.

The size of the electrical service is sufficient for typical single family needs. Inspection of the electrical system revealed the need for several minor repairs. Although these are not especially costly to repair, they should be high priority for safety reasons. *Unsafe electrical conditions represent a shock hazard. A licensed electrician should be consulted to undertake the repairs recommended below.*

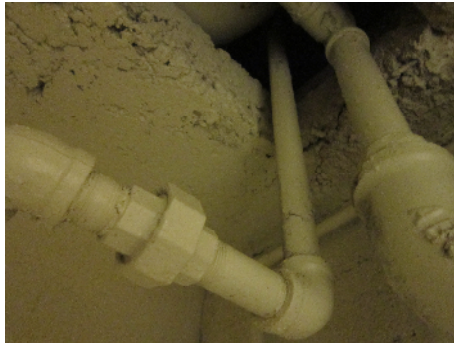
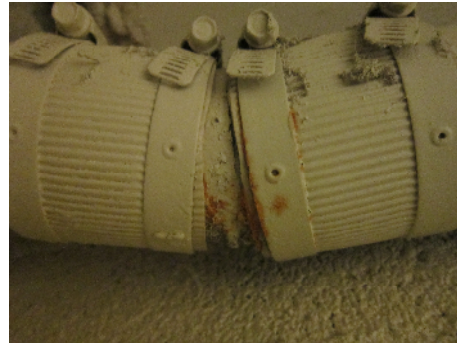
- **Monitor:** The old steel piping in the second floor bathroom is subject to corrosion on the interior of the pipe. As corrosion builds up, the inside diameter of the pipe becomes constricted, resulting in a loss of water pressure. This piping is typically replaced when the loss of pressure can no longer be tolerated. **Main bath tile surround, galvanized plumbing suspected in use.**

A qualified plumber should further evaluate the drain system from the upper bath, and the galvanized supply piping to the upper bath tub and shower.

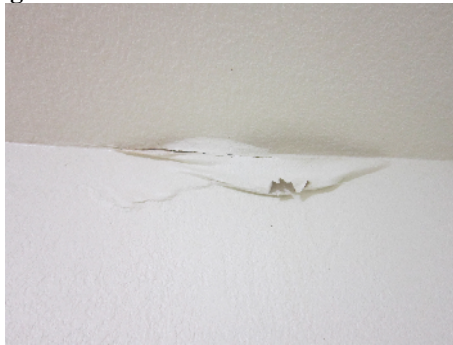
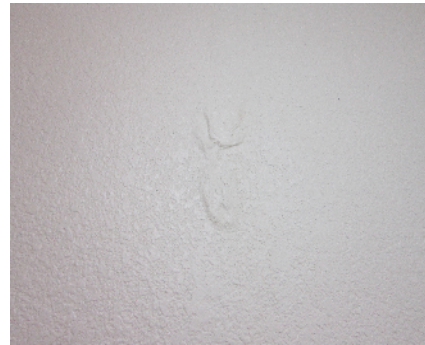
Water damage was observed in the second floor bath. Sagging drywall on the ceiling was observed in the upper bedroom closet. Evidence of roof leaks. Possible mold due to non removal of wet drywall and possible continuing roof leaks. See Roofing Section.

- **Monitor:** An apparent water staining was noted in the second floor bathroom. The area was dry at the time of the inspection, but due to the lack of recent rain we are unable to determine if the stain is still active. Recommend consulting with the current owners for additional information prior to closing. If the leak is still active, we recommend repair/replace as needed to remedy the leak.
- **Monitor, Repair:** Water damage was noted in the second floor bathroom.
- **Monitor:** Evidence of patching was detected in various locations.
- **Monitor:** Damage to the interior finish was observed in various locations.
- **Monitor:** Textured or "popcorn" ceiling material was visible in various locations. Asbestos detection or testing is beyond the scope of this inspection.

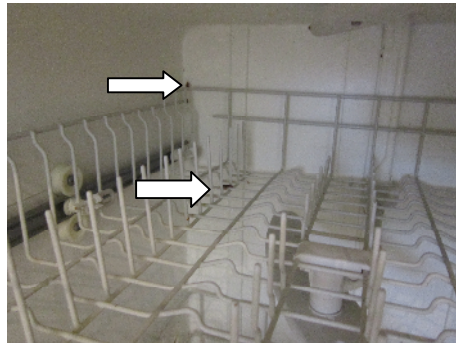
Live roaches were observed inside the dishwasher. Roach powder was observed on the floor behind the stove and refrigerator. Recommend insect exterminator.

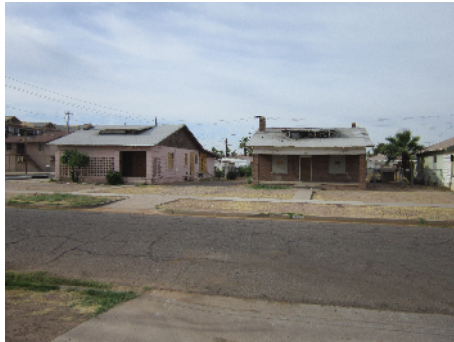
Abandoned homes across from subject home
